# **Bagrati Cathedral and Gelati Monastery, C 710**

## State of Conservation Report

# **Architectural Rehabilitation of the Church of the Virgin (12th-18th) at Gelati Monastery**

## **Technical report of the Restoration Works**

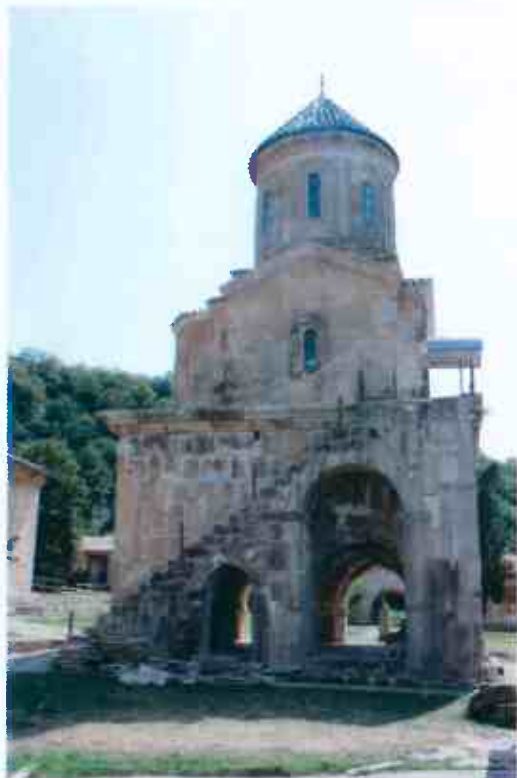
Before

### Rehabilitation of St. Nicolas's stairs and platform:

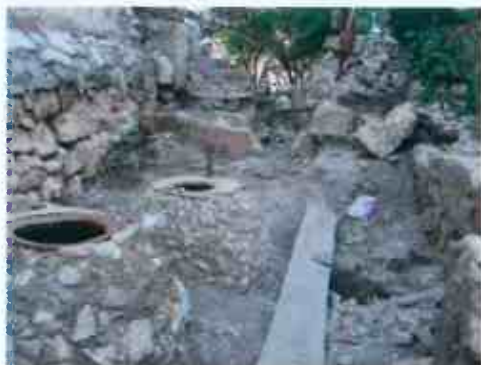
Before

### Preservation works of the East wall of the King David's gate

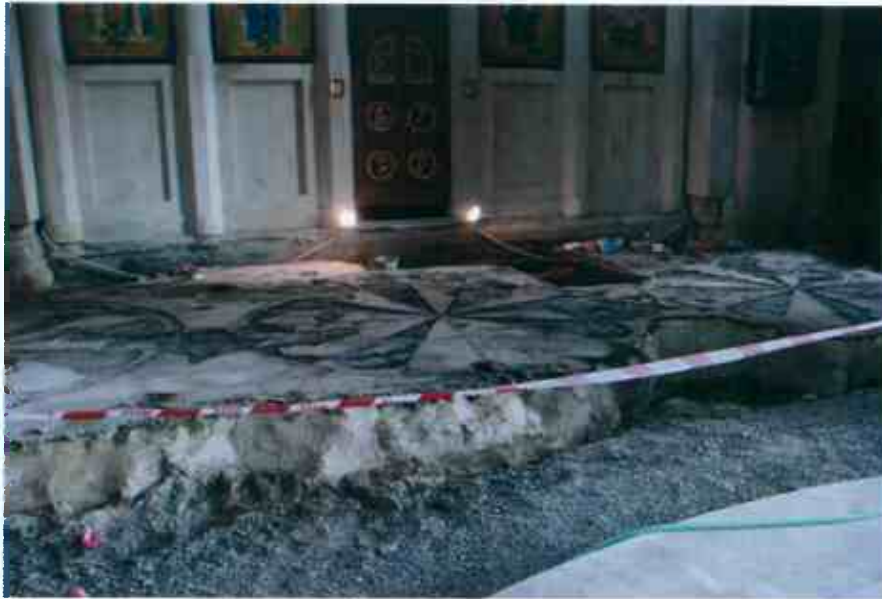
### Before

The physical arrangement of the Bagrati Cathedral floor, according to the design elaborated in 2013 and approved by the Cultural Heritage Council of the NACHPG was completed in 2014.

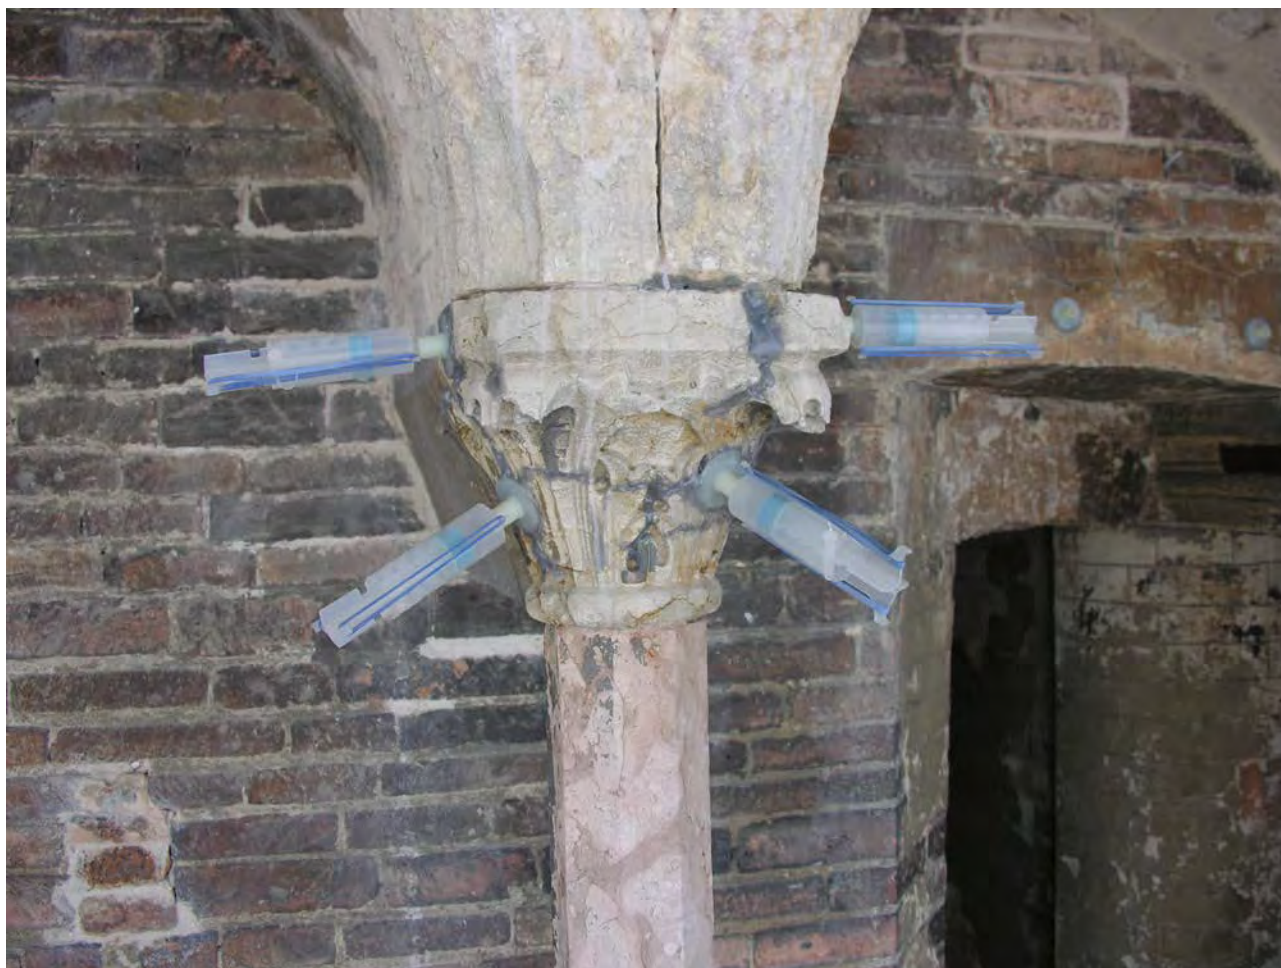
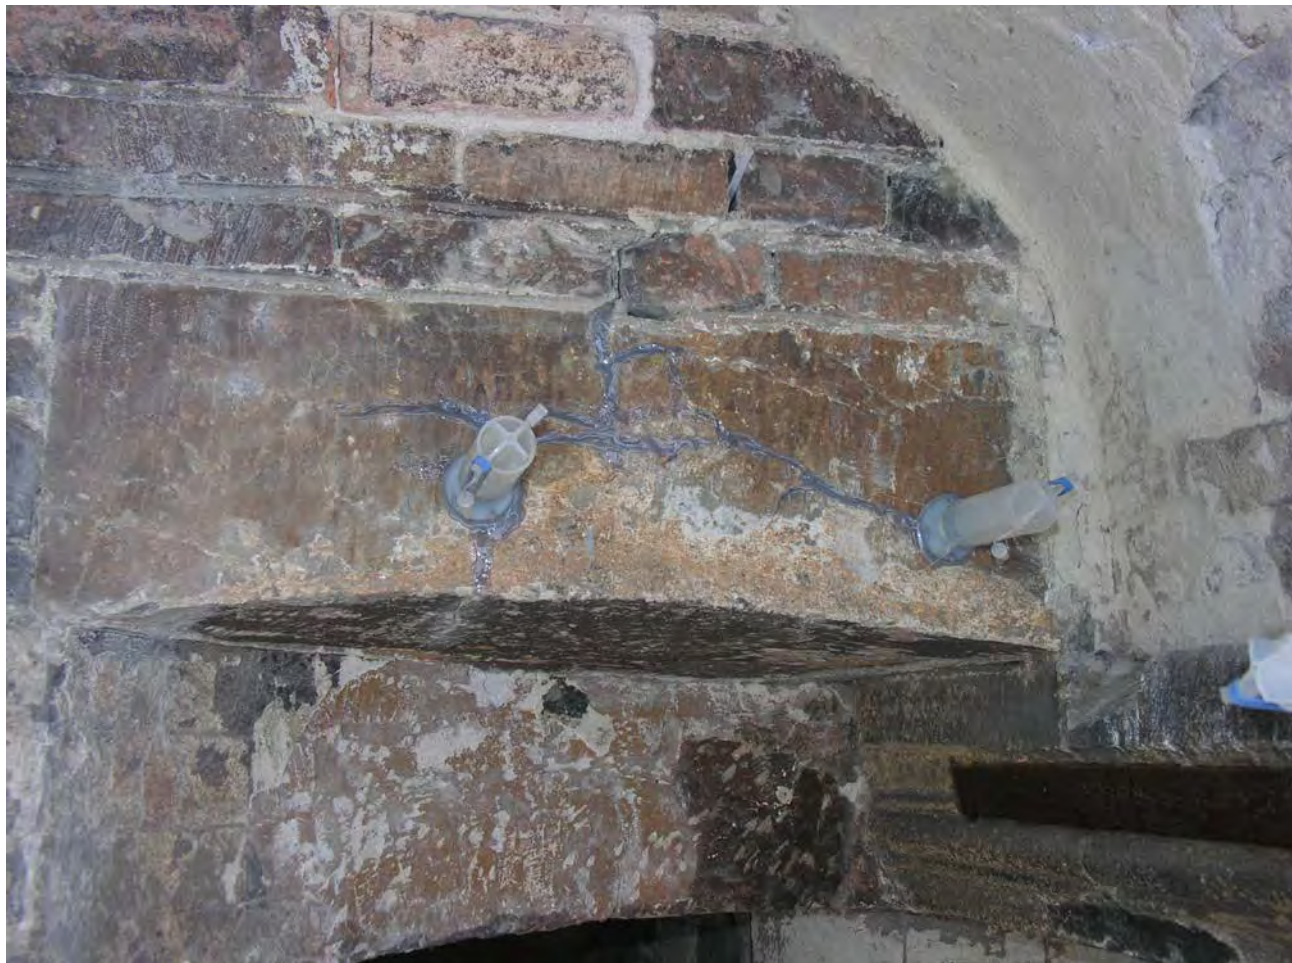
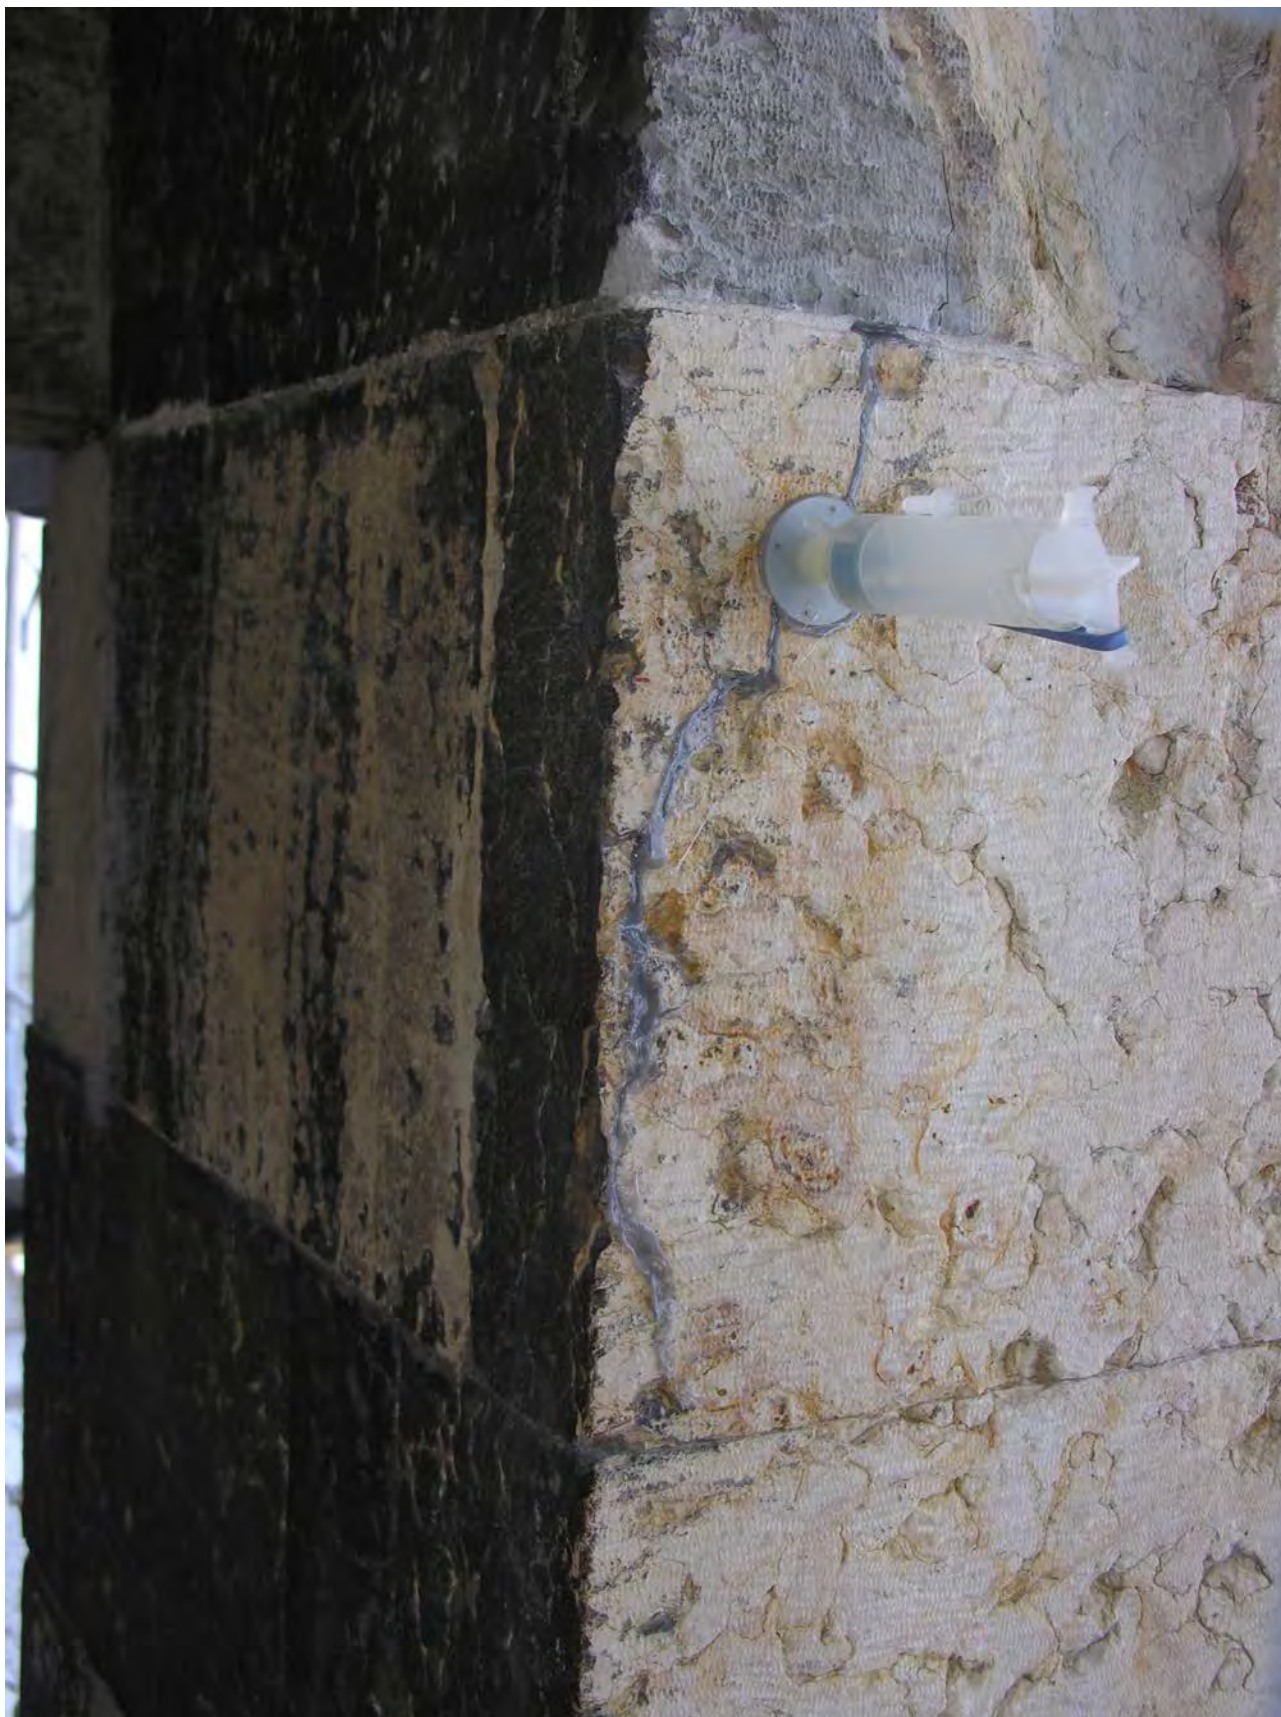
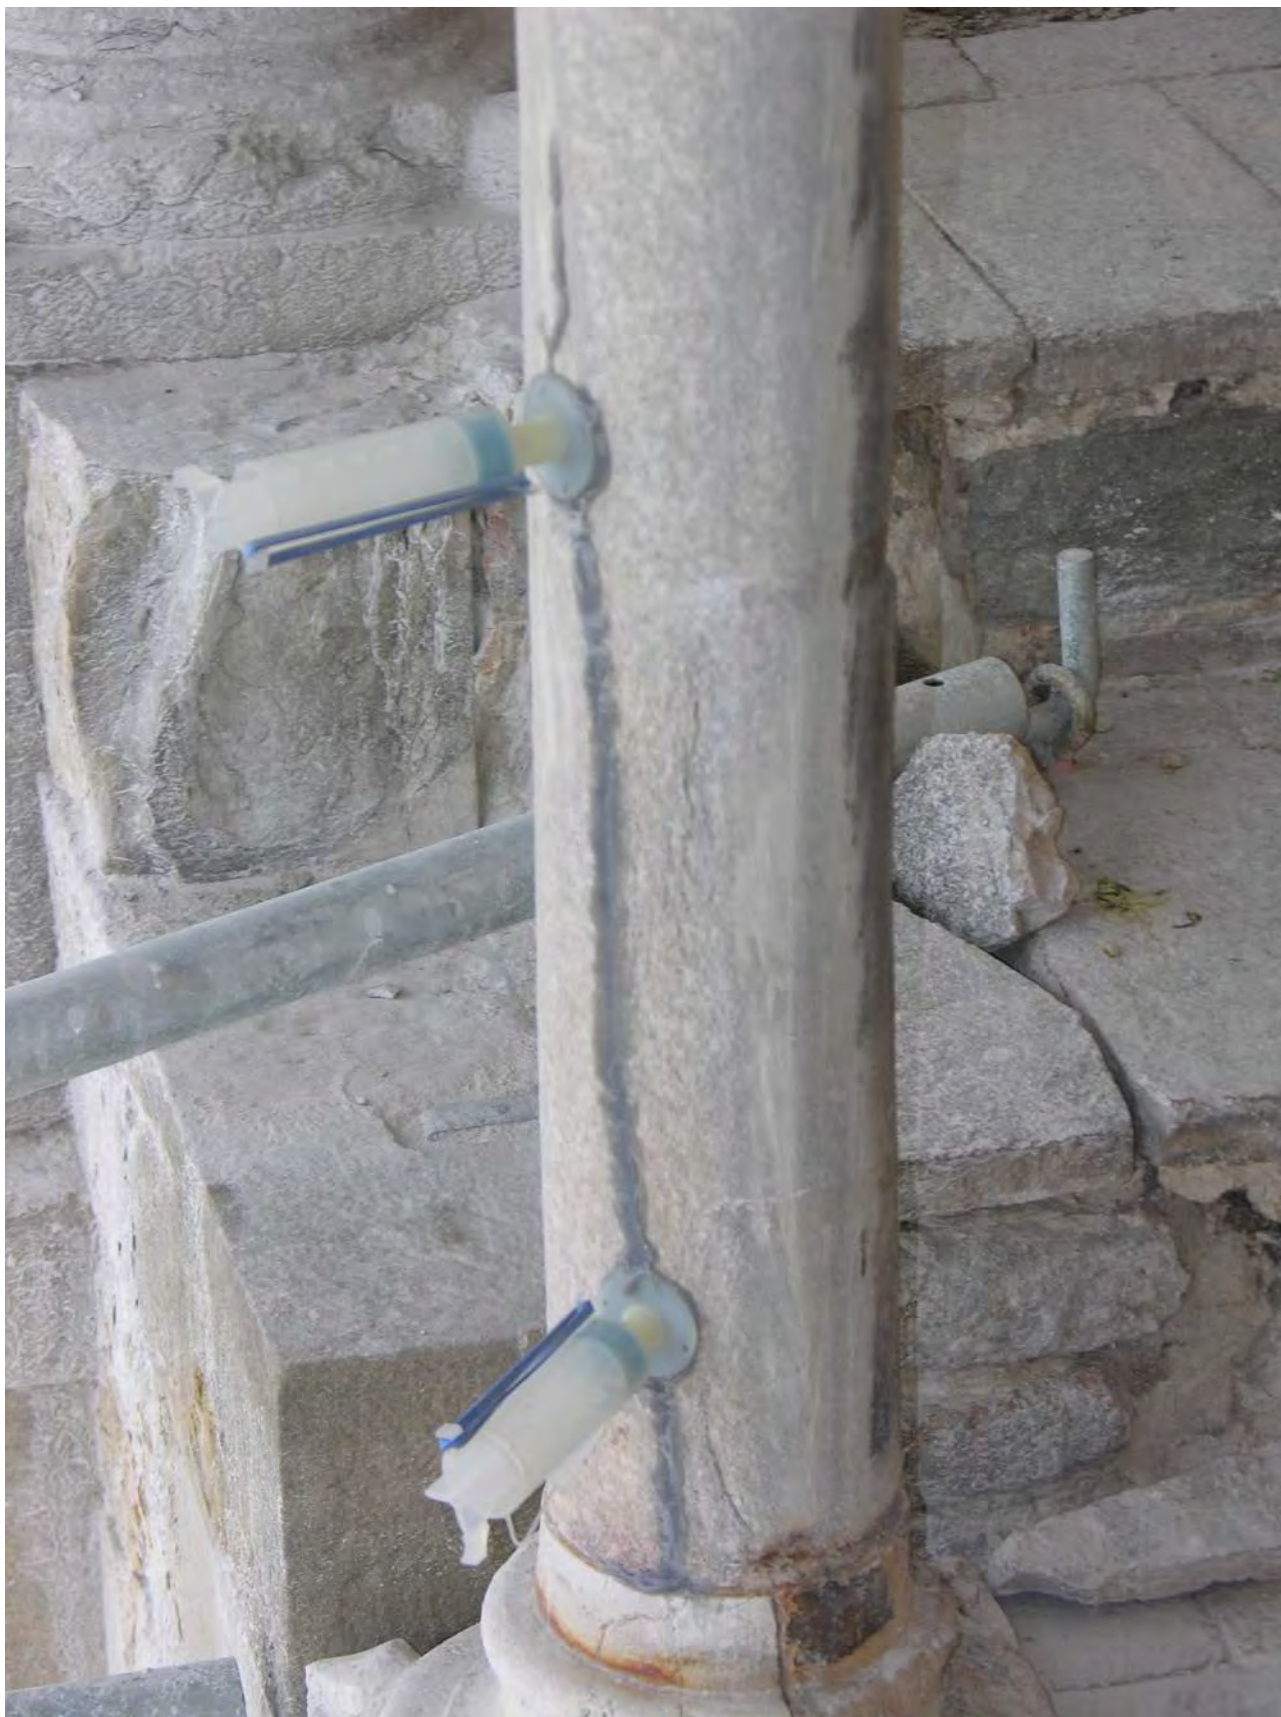
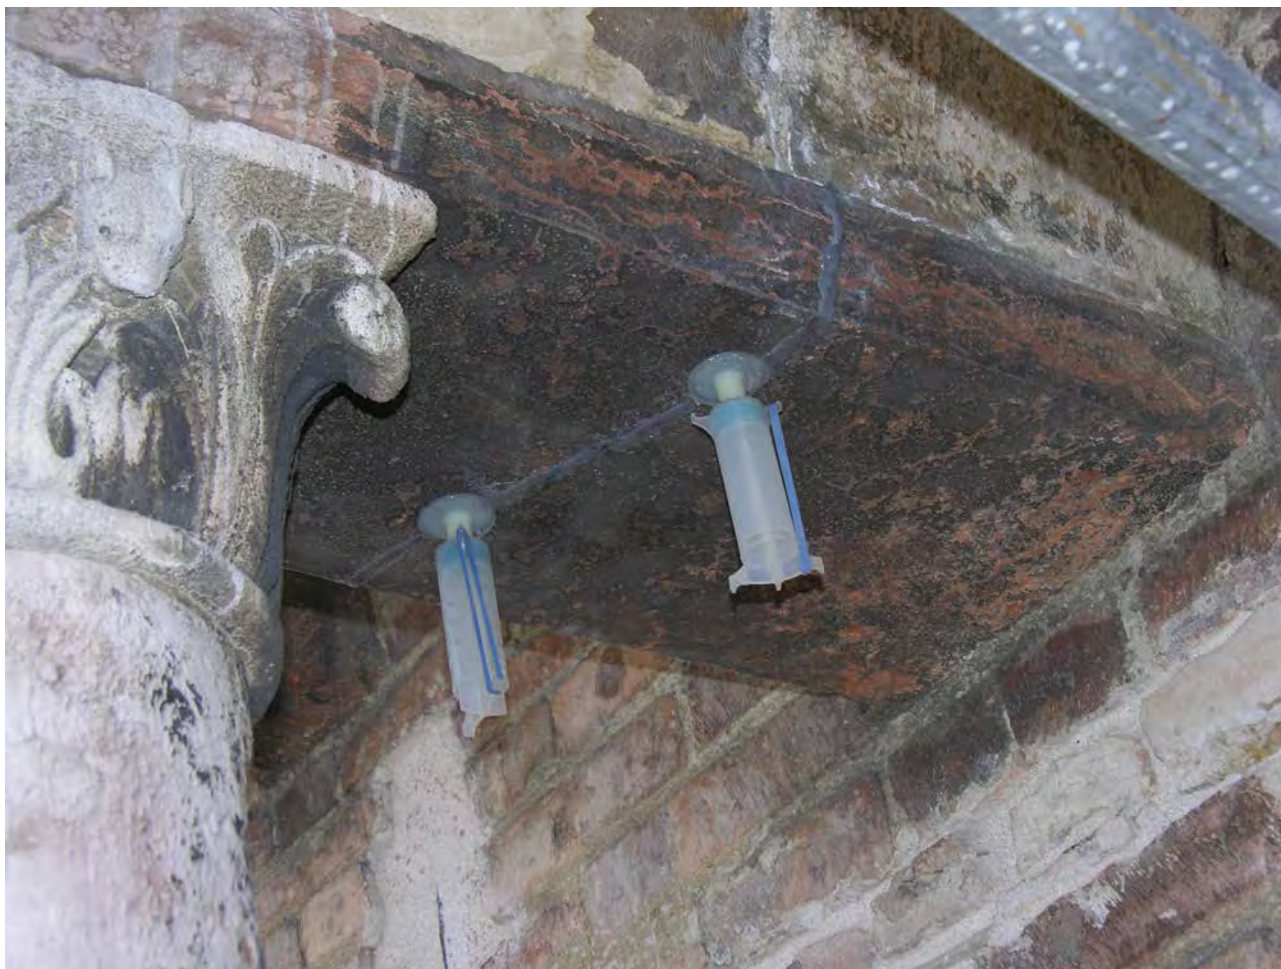
CATTEDRALE DI PARMA

Images of system of structural injection are attached.

- Structural consolidation of fissures-fractures of single ashlar with low elastic modulus and low viscosity epoxy resin by means of continuous injection in sealed cell, to avoid air bubbles formation. Fissures-fractures will be previously sealed with a 30% solution of Paraloid B 72 and thermofusible glue injected through an injection pipe. Both products are 100% reversible. After this preliminary procedure low catalyzation epoxy resin (24h. type CHERECO SYSTEM 102, viscosity at 25°C 230 cps) will be injected. After catalyzation, syringes and pipes will be removed and surfaces cleaned with acetone.

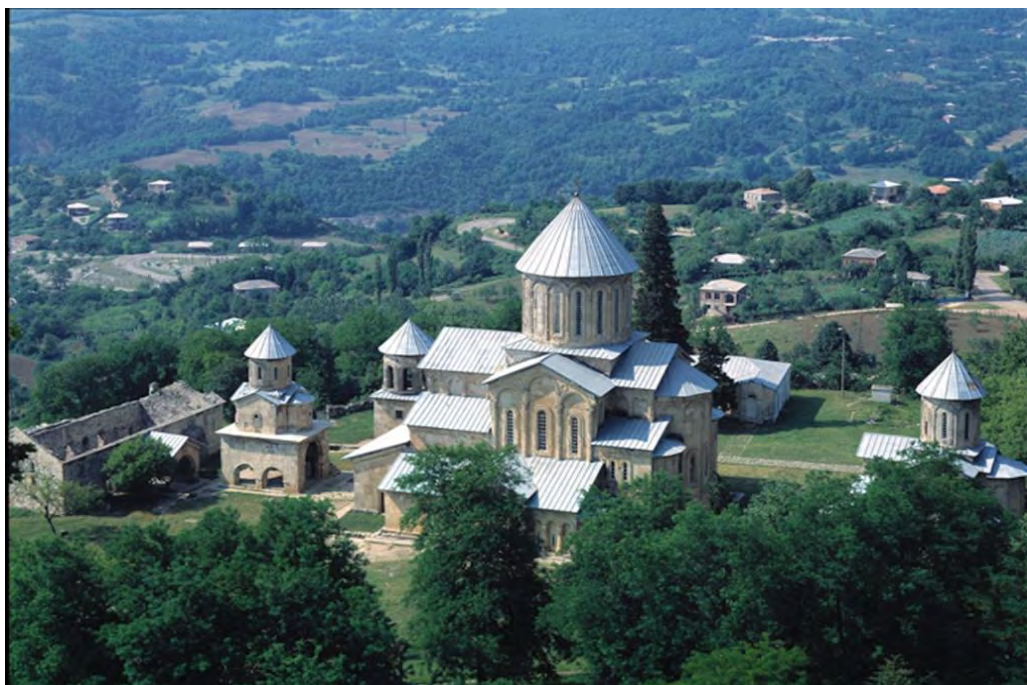
**Fig.1.**

According to the practice, existing in restoration-rehabilitation processes, running 50<sup>th</sup> of XX century, for roofing of complex main structure, the tin covering was selected (Fig.1), that existed at the restoration-rehabilitation project beginning, and, at some places, exists up to day. The tin, in the traditional style, was located over the wooden rafters. The past period had revealed that such type choice was not reasonable from the functionality point of view.

The covering at present is amortized, and cannot ensure the safety of the temple frescos, beside this, its extended overhang (approximately, 30-40 cm) is not fit to the structure proportions and represents the danger for the stone cladding. Naturally, the purpose of restoration

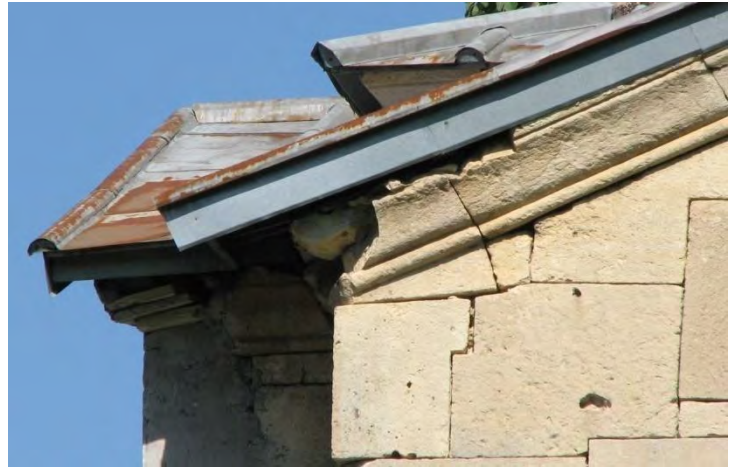
**Fig.2.**

was the water drainage as far as possible from the wall. Unfortunately, for solution of this task mentioned approach revealed not enough, as far as the main part of the church walls is damaged due to atmospheric water. The data of measuring provides the detailed information about the damages, and the height of the temple of the Virgin. The measuring data shows the big number of the stones, damaged due to atmospheric precipitations, is great.

The engineering-structural research, carried out in the project confines, has brought to light, that the existing structure is one of factors, causing the cornice damage, as far as, it due to natural phenomena, permanently suffers vibration (Fig. 2, 3).

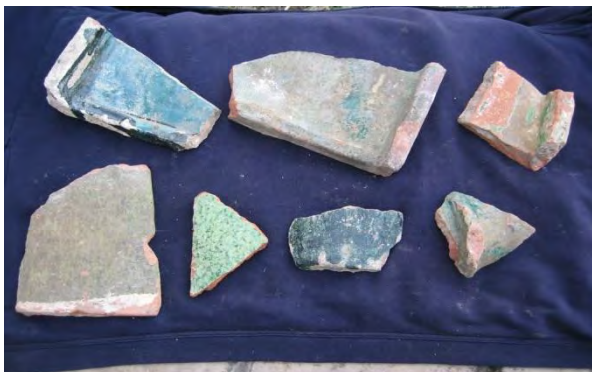
**Fig. 4.**

According to written sources, archive materials, graphical illustrations, available for us on given stage, materials accumulated by employees of the Kutaisi-Gelati museum-national park on the complex territory from time to time (mainly before the 1988), and archeological works, executed in 2008 on the complex territory, there is brought to light, that for the covering of complex separate structures the tiles, glazed in different tonality were used. The samples of these tiles were exhibited in 1988 in the building of former residence of the bishop Gabriel Kikodze. Though, the confirmation, whether the tile fragments are contemporary of the temple construction, or not, is not easy. Tile fragments

have different colors: light blue, greenish-turquoise, green, light brown (Fig. 4).

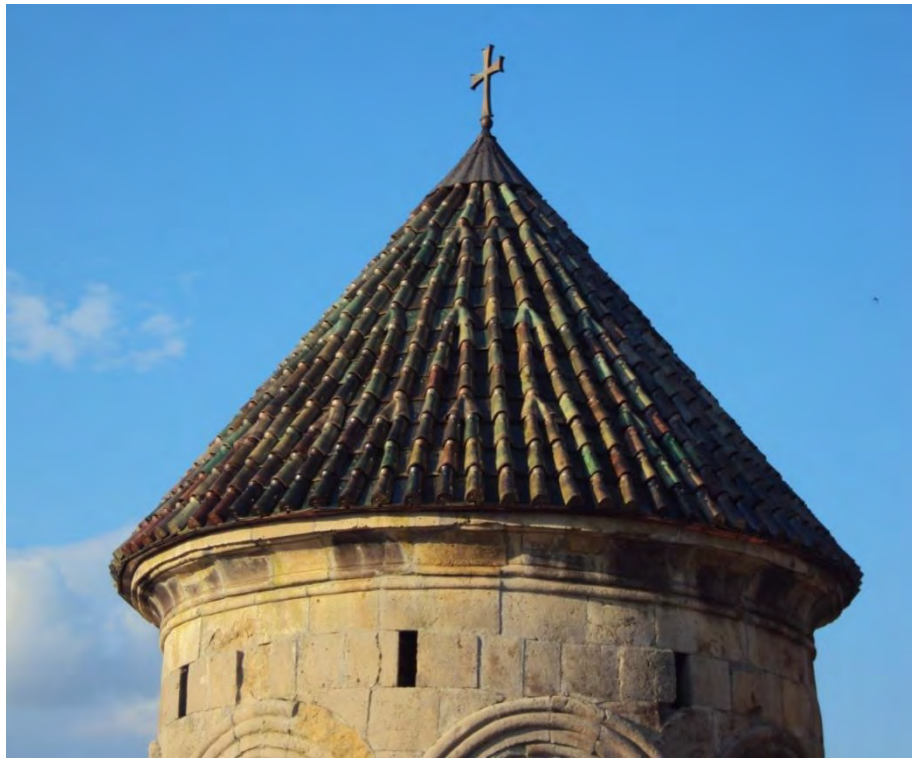
**Fig. 7**

The bell tower and Saint Nicholas temple were covered using the tiles of green tonality (Fig.7,8) that represents the mix of rusted copper and ochre tonalities and proportionally to the light variation creates entirely different gamut of colors.

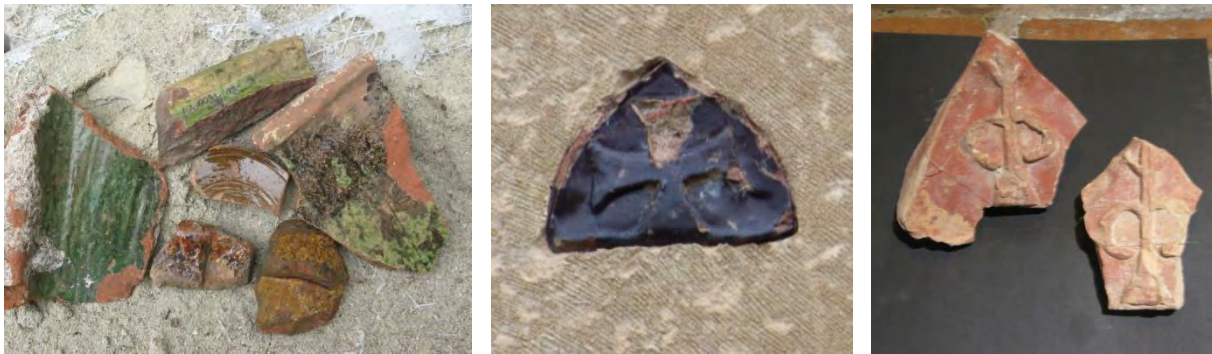
Altogether seven main and six additional elements were elaborated:

- 1 – Flat tile with the wavy front for laying on the cornice;
- 2 – Lower, flat tile with folded sides and rib for the upper tile holding;
- 3 - Lower, flat tile with folded sides in form of the isosceles trapezium;
- 4- Antefix, upper tile with channel and relief front side;
- 5 – Upper basic tile with the channel;
- 6 – Upper ‘pants’, joining two rows of tiles with channel;
- 7 – Conic end of the dome, elements of tile with plural wings, underlying the cross;
- 8-13 –Trapeziform tiles of different sizes for fitting of basic tiles with folded sides.

All tiles are provided with the holes for the fastening.

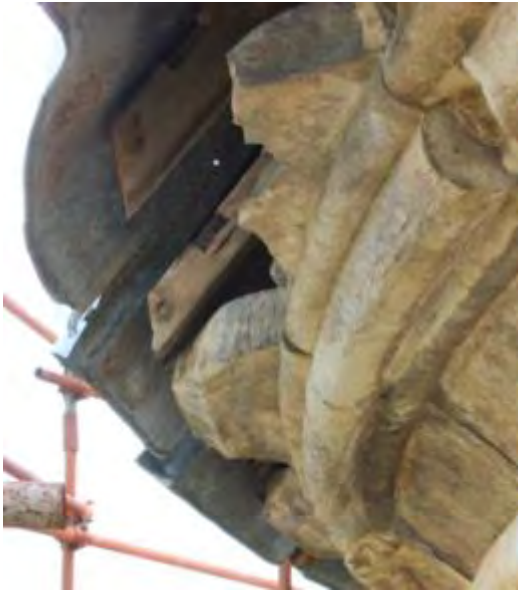
At the initial stage of the working process the wooden rafters, which being in direct contact were damaging the cornice stones, were shortened.

*Fig. Rafters before the shortening*

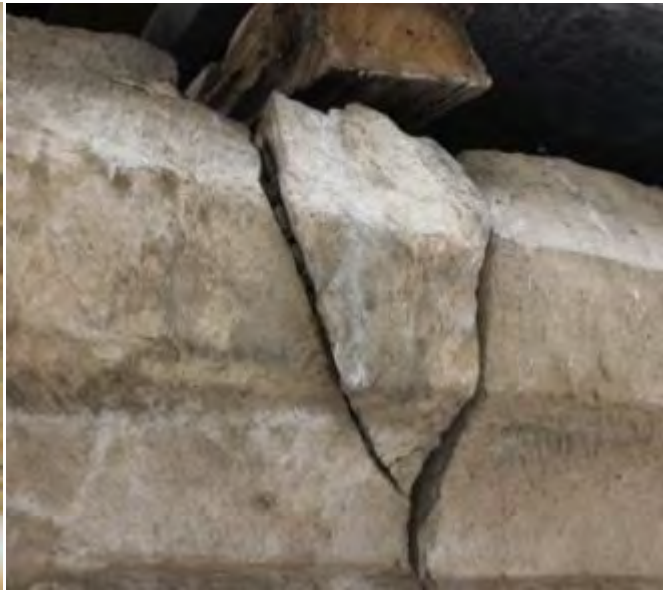
*Fig. Stones damaged/ affected by rafters*

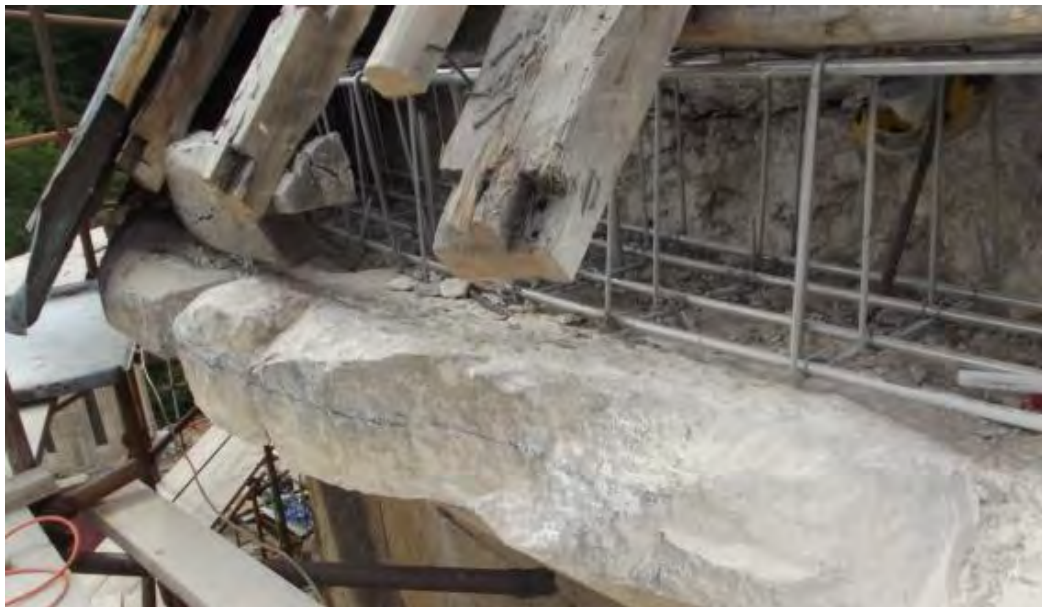
*Fig. Shortened Rafters*

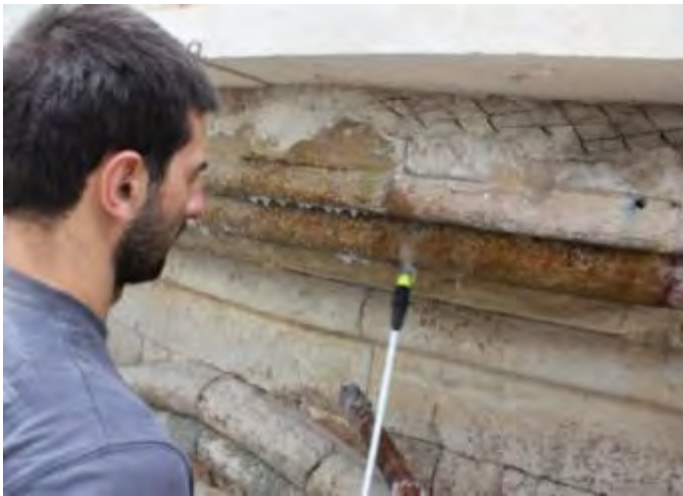
*Fig. Treatment process*

The entire perimeter of the cornice was treated with Benzalkonium chloride against the micro flora. The treatment has been repeated twice during the reporting period.

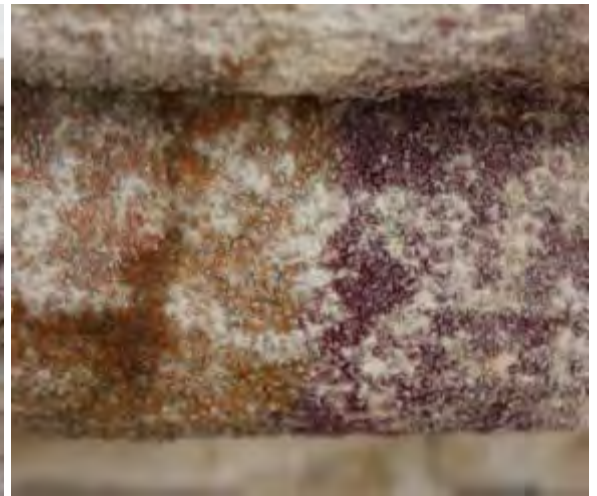
*Fig. Biological damage*

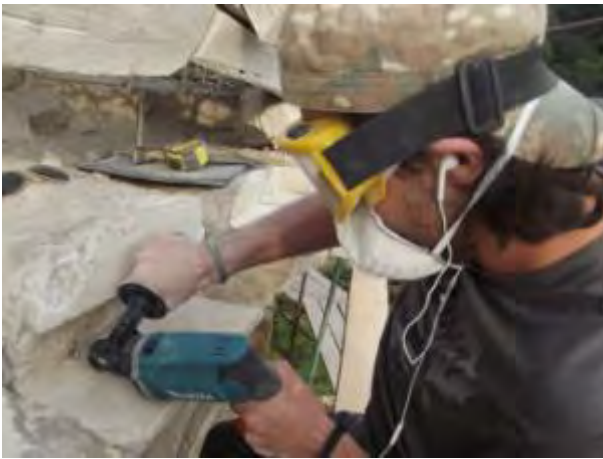
*Fig. Preparing the holes for anchoring*

The exact points for the anchoring were determined. The wholes for anchoring have drilled, cleaned with air jet and treated with acetone solution. Stainless steel anchors were prepared, cut in individual size and bent with appropriate degrees. Diameter of holes - 14mm, diameter of anchors - 12mm, depth 15-30cm.

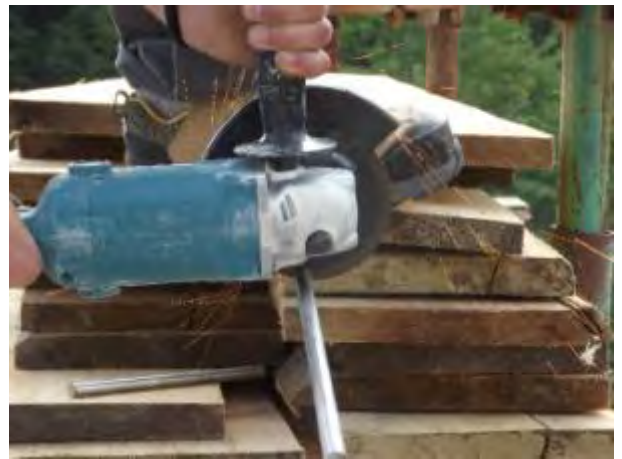
*Fig. Preparing anchors*

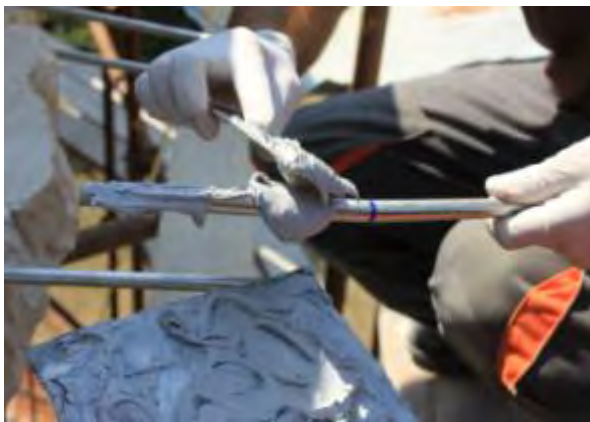
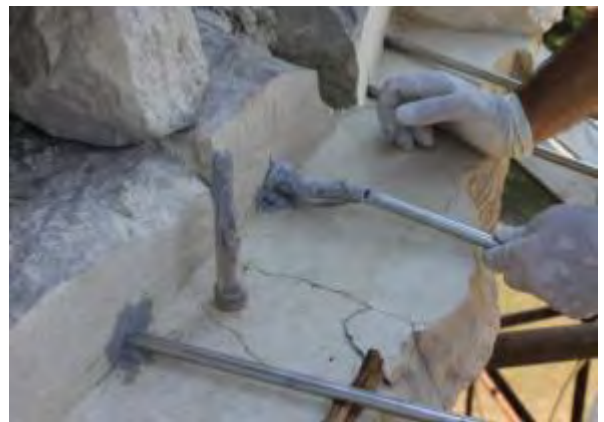
*Fig. The working process*

Stainless steel anchors were fixed in the prepared holes with the two-component glue.

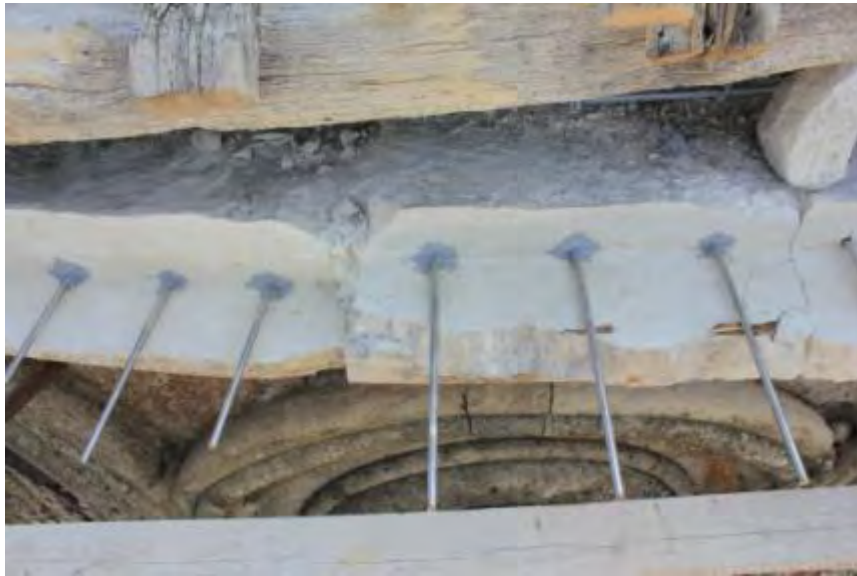
*Fig. Anchors*

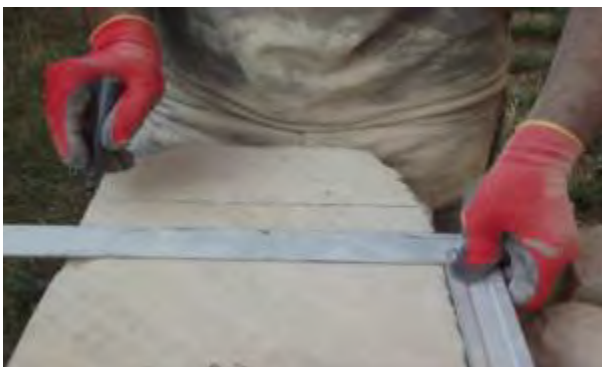
*Fig. Sizing*

The stone details compatible with cornice stones for each specific section were individually prepared. Holes for anchoring were drilled, surface treated with special hammer and fixed with the lime mortar.

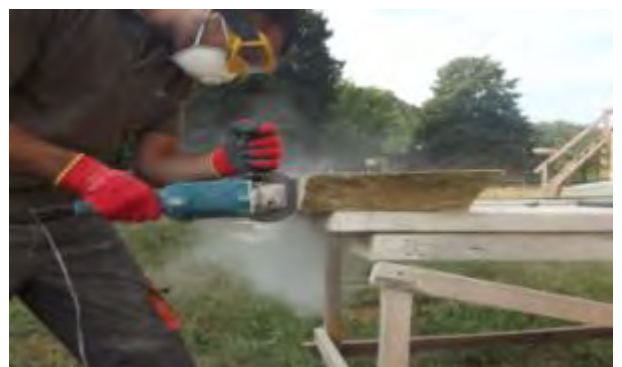
*Fig. The stone cutting*

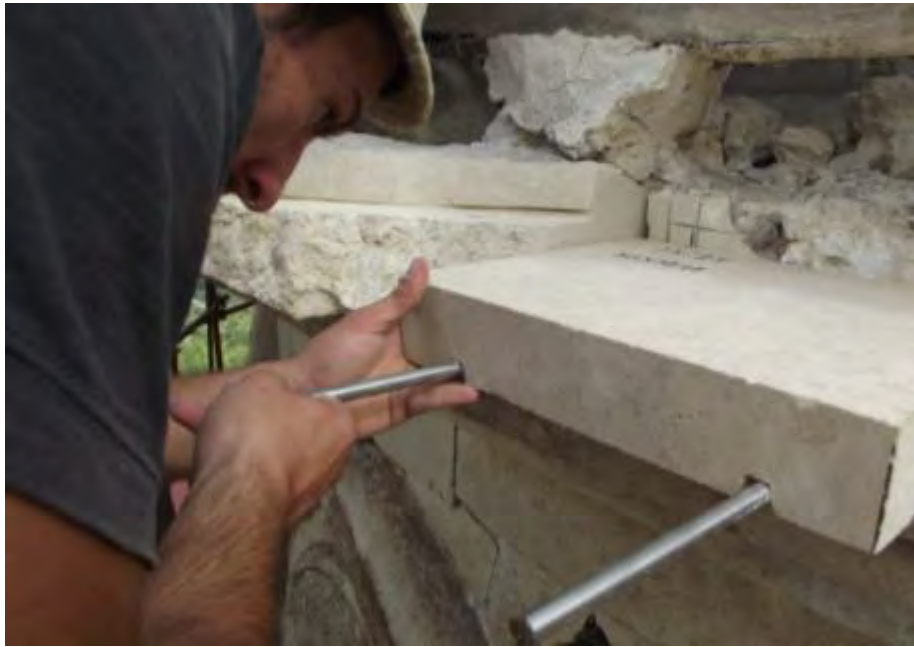
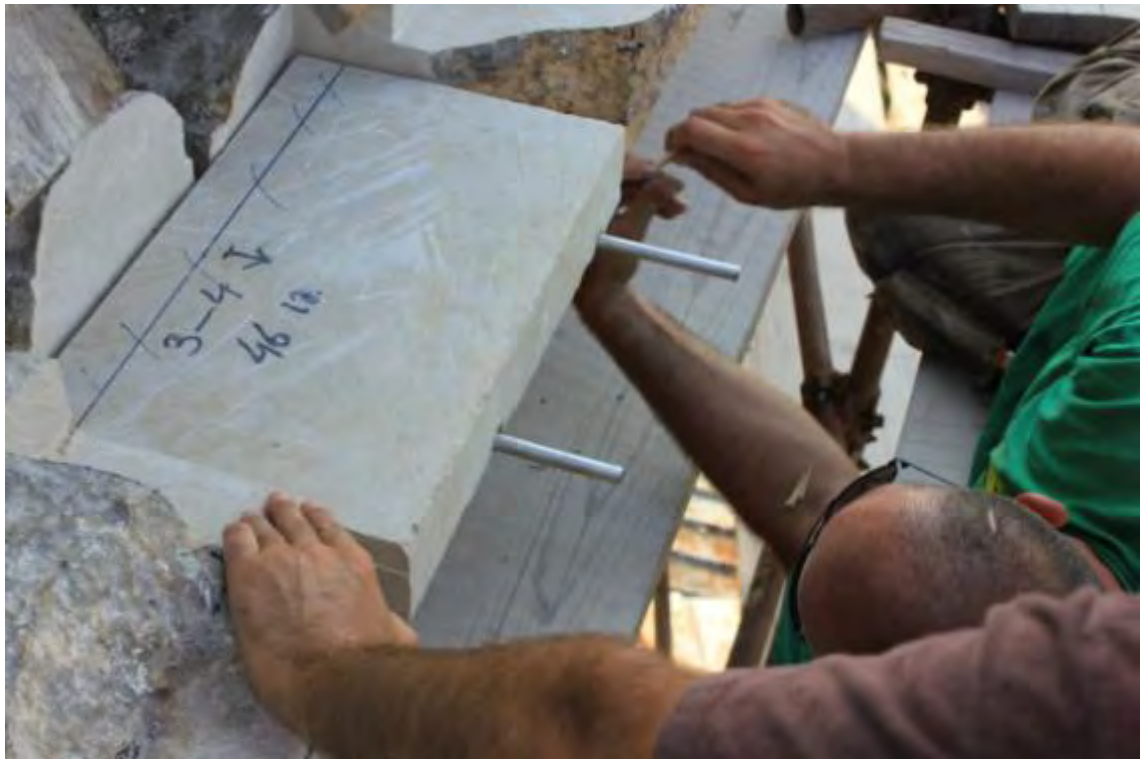
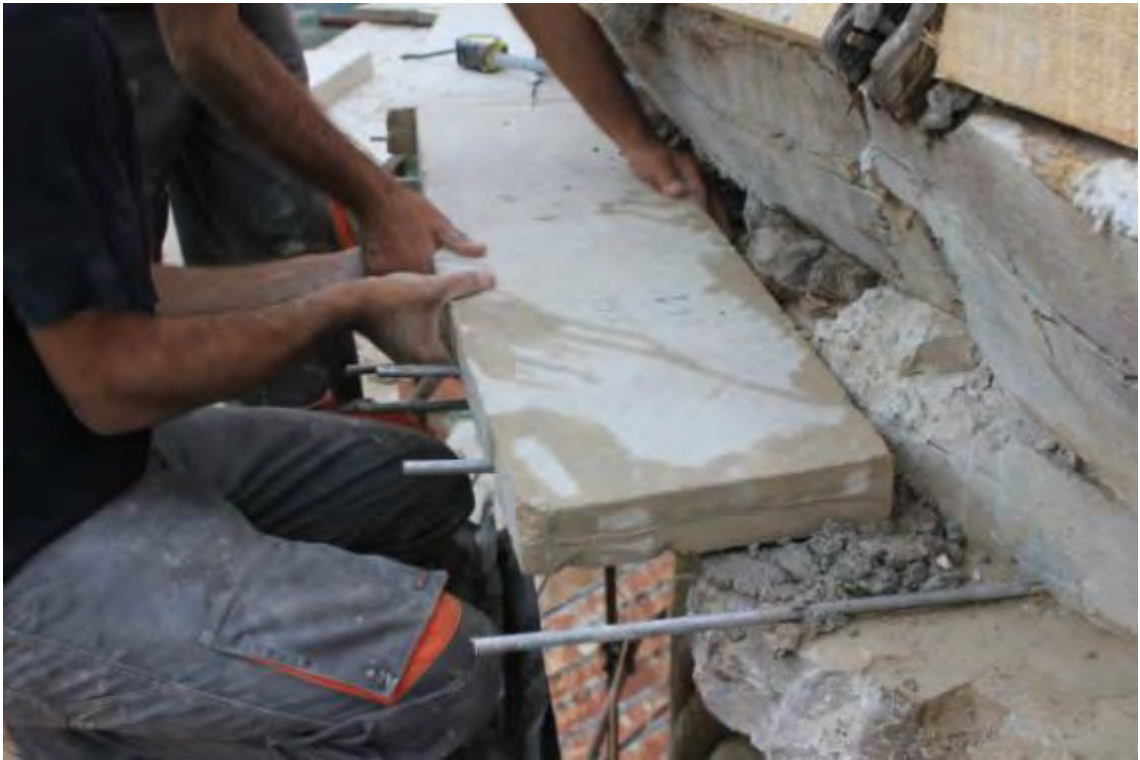
*Fig. Fixing*

*Fig. Fixing the stone*

*Fig. Fixing with the lime mortar*

The proportion of the lime mortar: 1 share of lime, 1 share of quartz sand, 1 share of black sand (thick fraction), 1 share of pozzolana.

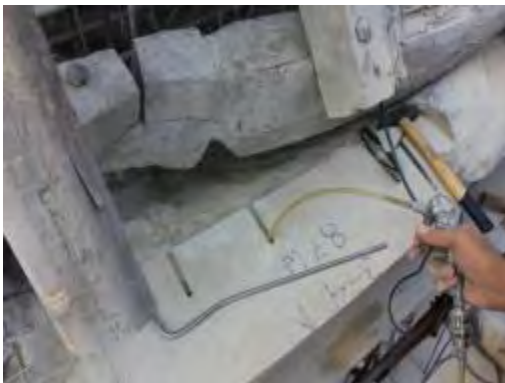
*Fig. Cleaning anchoring holes*

Adjusted new stone details, were fixed to the existing cornice and stainless steel belt frame by the fork type anchors. For these procedure the anchoring holes with diameter 6mm and 10 mm were prepared and cleaned by air jet and acetone mixture. Fork type anchors were produced from stainless steel stem of 4mm and 8mm diameter. The anchoring had been conducted with the use of two-component glue (epoxide ).

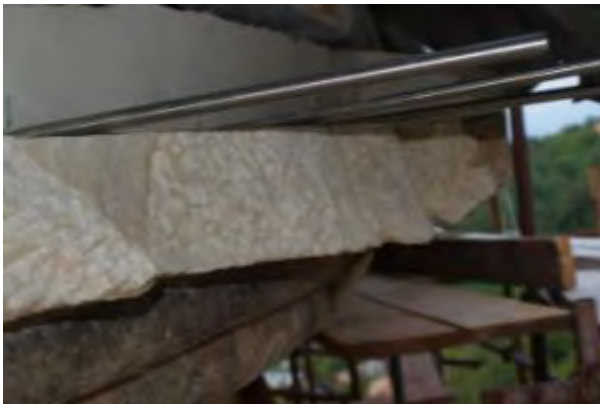
*Fig. Treated stone surface*

The reconstruction of the relatively less damaged cornice stones was done by lime mortar with following composition: 1 share lime, 1 share quartz sand, 0,5 share marble powder, 0,5 share black sand, 1 share pozzolana, 0,5 share white stone peddles of middle fraction and fibrous material. In some cases, to gain higher durability, the stainless steel frames had been arranged inside the plaster. The notches had been cut on the existing stones in the segments where increase of the grip force of lime mortar was needed.

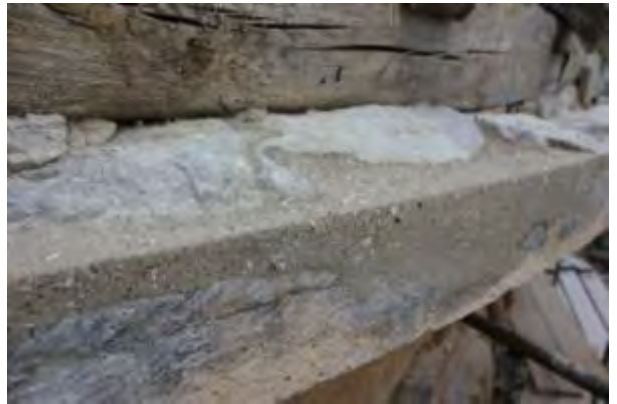
*Fig. After the reconstruction*

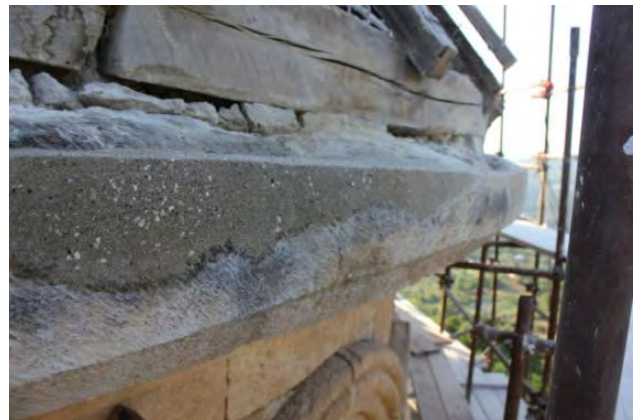
*Fig. The cornice detail after the reconstruction*

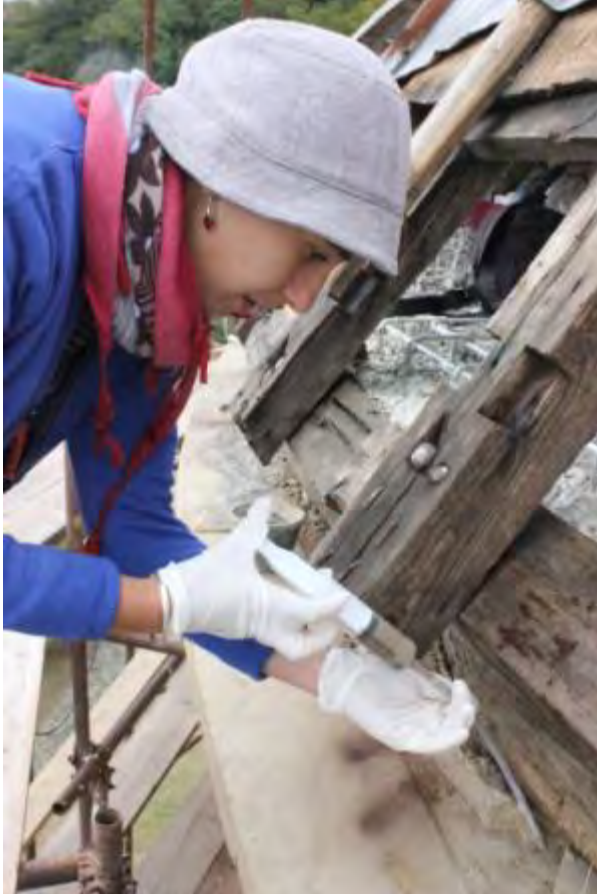
*Fig. Injection*

At the final stage, joints between the stones were injected. The injection mixture proportion was: 1 share pozzolana, 2 shares natural hydraulic lime *NHL5*.
