*State of Conservation report of "the Persian Qanat" and "Susa" World Heritage Sites*

**Report on the state of conservation of Susa World Heritage Site**

## **Introduction**

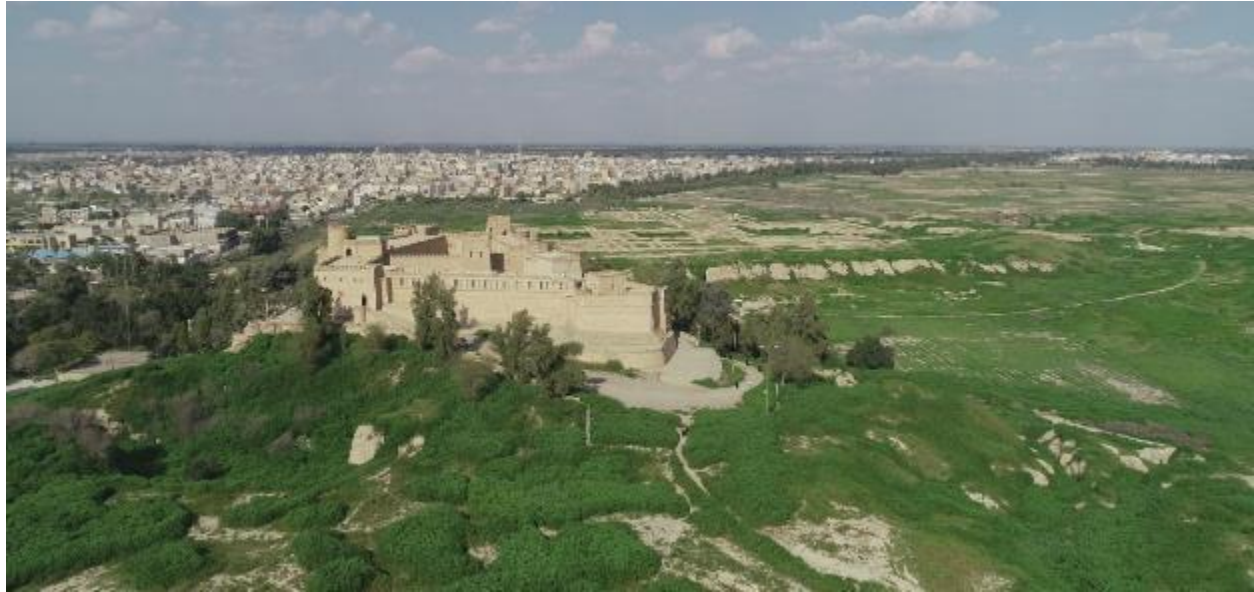
*Figure 32. Outgrowth of plants in Susa World Heritage Site*

Dealing with vegetation to prevent from damages to architectural structures and archeological layers has been carried out in the past two years, like the years before, within the Ardashir Palace, Apadana Palace, the eastern gate of Apadana Palace, Hadish, the fifteenth city and Achaemenid village. However, the most noticeable case is removing *Prosopis Fracta* trees from large eastern trench of Apadana Palace. In this section, the climatic condition provided the setting for outgrowth of the specie so that some trees grew as high as 7m.

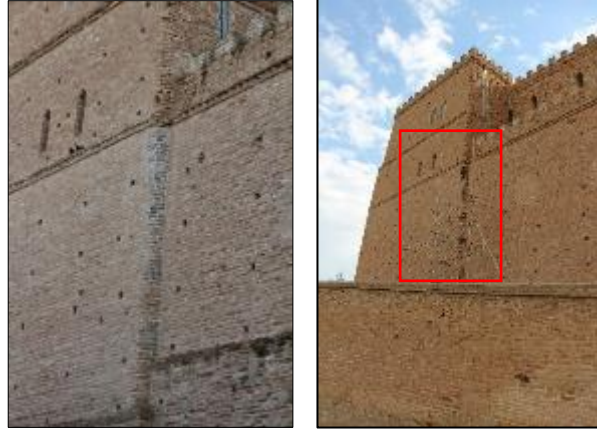
Over the years, certain parts of external wall in western corner of the structure had been damaged which are restored and the vulnerable bricks substituted at heights.

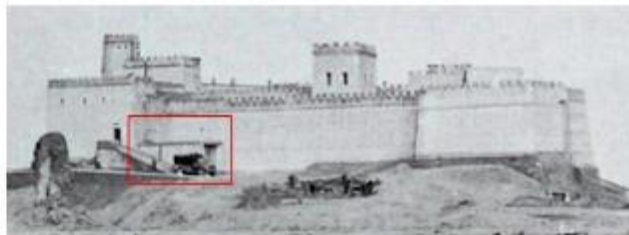
Figure ۵۳. Initial status of Girshman Garage used as a storage area

دو نما از قلعه شوش پیش و پس از ایجاد گاراژ توسط گیرشمن

- 1- Evacuation of unnecessary tools and building materials;
- 2- Restoration of the roof;
- 3- Reorganization of the pavement;
- 4- Substitution of the deteriorated door;
- 5- Cleaning and stabilization of inscriptions;
- 6- Substitution and completion of lighting and air conditioning systems;
- 7- Designing and producing presentation signs and their installation.
